**WETLAND INVESTIGATION &  
WETLAND FUNCTIONAL ANALYSIS**  
of a  
**SMALL WETLAND AND ADJACENT LAND**

on the  
**GATEWAY SUMMIT SITE**  
**ROUTE 6**

**CARMEL, NY**

Jan. 28, 2002

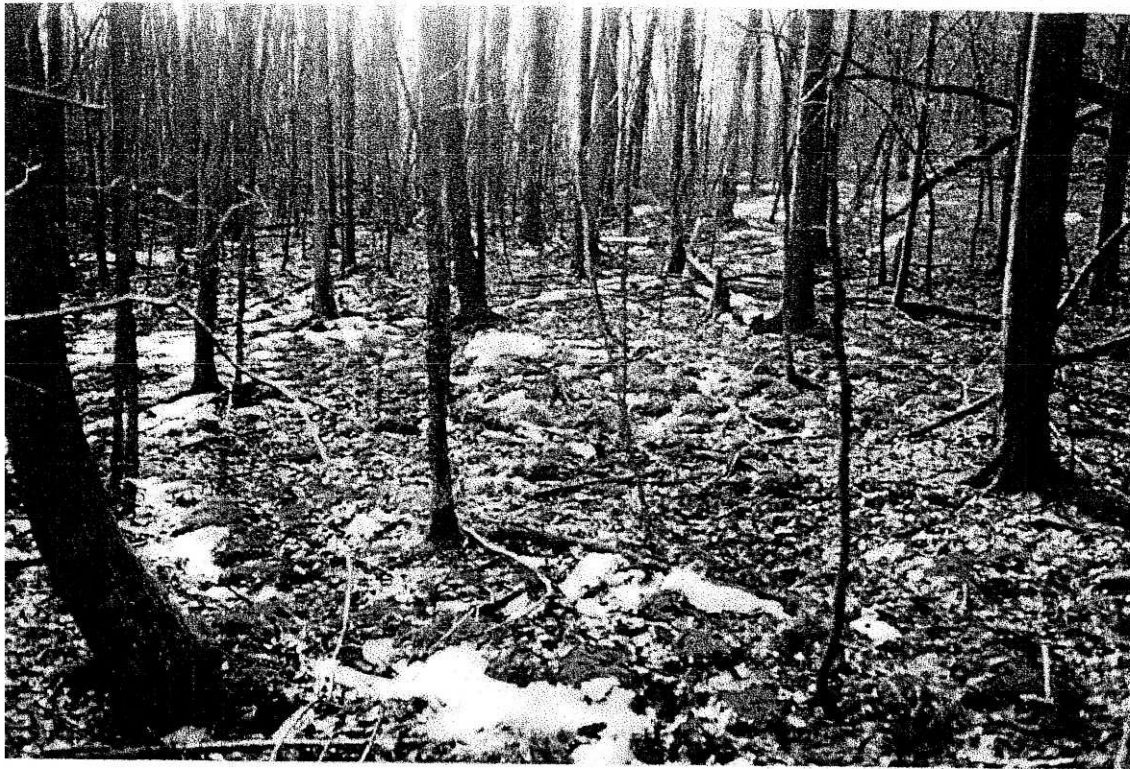
**PHOTO 1** LOOKING NORTH ACROSS ECB WETLAND ON WESTERN PORTION OF WETLAND. NOTE RED MAPLE TREES WITH SHALLOW ROOTS; CLUSTER OF TUSSOCK SEDGE IN MIDDLE OF PICTURE WHERE AUGER WITH PINK RIBBON IS PLACED; STONES; SPHAGNUM MOSS

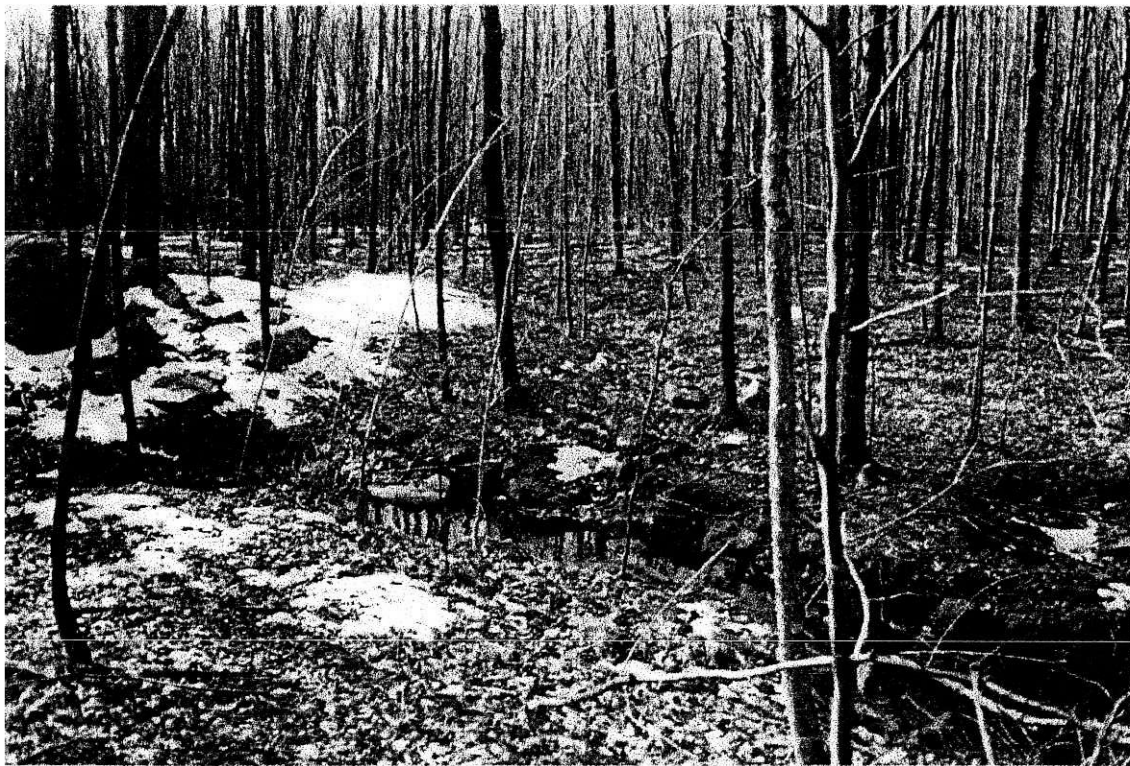
**PHOTO 2** LOOKING WEST ACROSS STREAM AND TOWARD NORTHEAST END OF ECB WETLAND AND SOUTHERN END OF AREA CONSIDERED FOR WETLAND CREATION. NOTE INTERMITTENT DRAINAGE OUTLET FROM ECB WETLAND INTO STREAM IN CENTER OF PHOTO; RED MAPLE WITH SHALLOW ROOTING IN PROPOSED WETLAND CREATION.

The land to the north and adjacent to ECB wetland is a gently sloped wetland similar to ECB wetland area (see *photo 2* in Appendix I). The vegetative cover consists of: a thin tree canopy of red maples and few ash; some shrub understory of winterberry, spicebush, few barberry; and groundcover including local tussock sedge, sphagnum moss, Christmas ferns. There is a shrub area, which includes red osier dogwood, in addition to other shrub mentioned previously, in the area adjacent to the stream. Tree root development is shallow. The soils in this area are wetland and identified as Ridgebury loam. Water tables were found to be near the surface in this area.

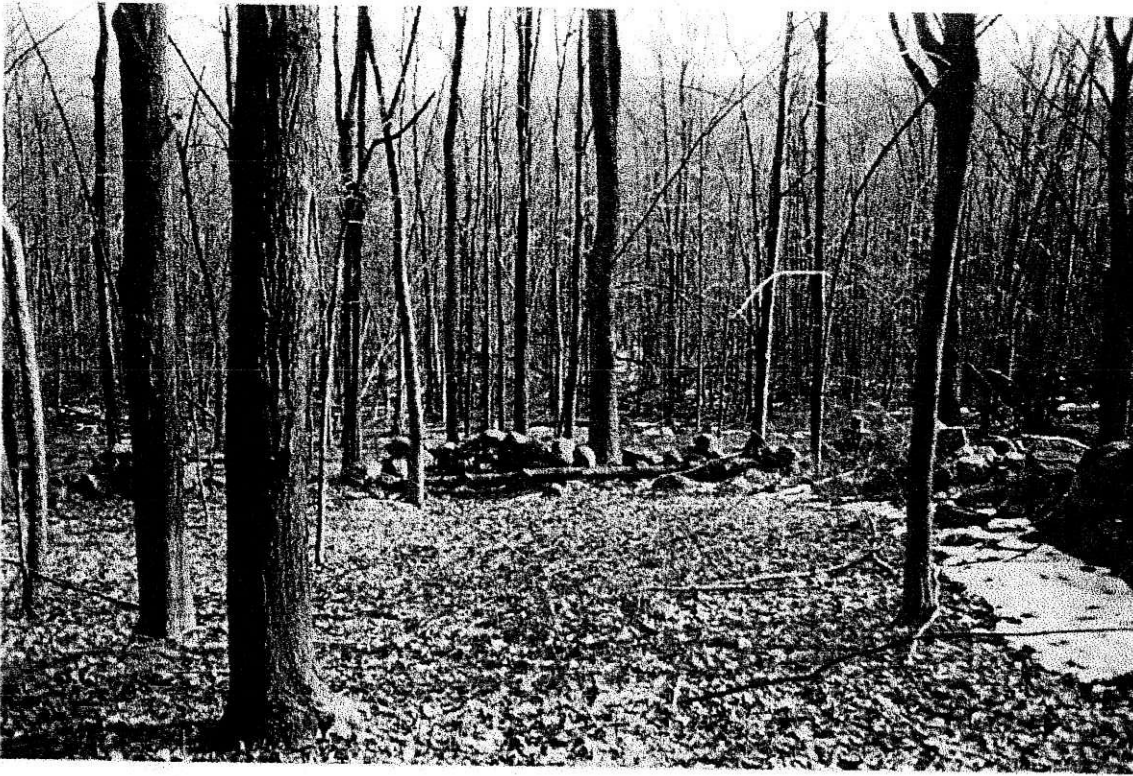
*PHOTO 3 LOOKING EAST DOWN SLOPE TOWARD ECB WETLAND FROM WOODED UPLAND.  
NOTE ECB WETLAND IS ACROSS BACKGROUND OF PHOTO.*

Land to the west of the ECB wetland is upland well-drained woodlands and would not be a suitable site for wetland creation because the anticipated depth of excavation to intercept the water table to replicate hydric conditions ( see *photo 3* in Appendix I).

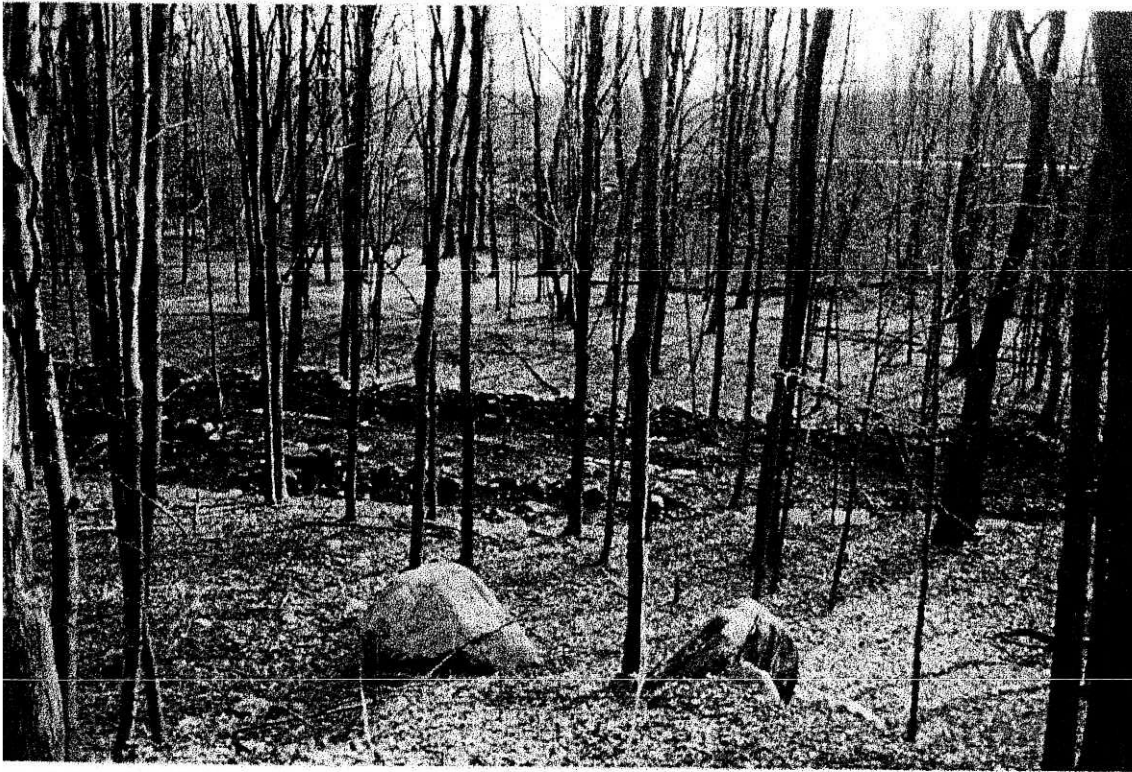
*PHOTO 4 LOOKING EAST DOWN SLOPE TOWARD STREAM COURSE NEAR ROUTE 6. NOTE STREAM  
ACROSS CENTER OF PHOTO; LEVEL WOODLANDS WITH OPEN UNDERSTORY IN BACKGROUND.*
