Appendix S  
Fracture Trace Analysis

# Technical Memorandum

**Subject:** Fracture Trace Analysis

**Re:** Gateway and Fairways

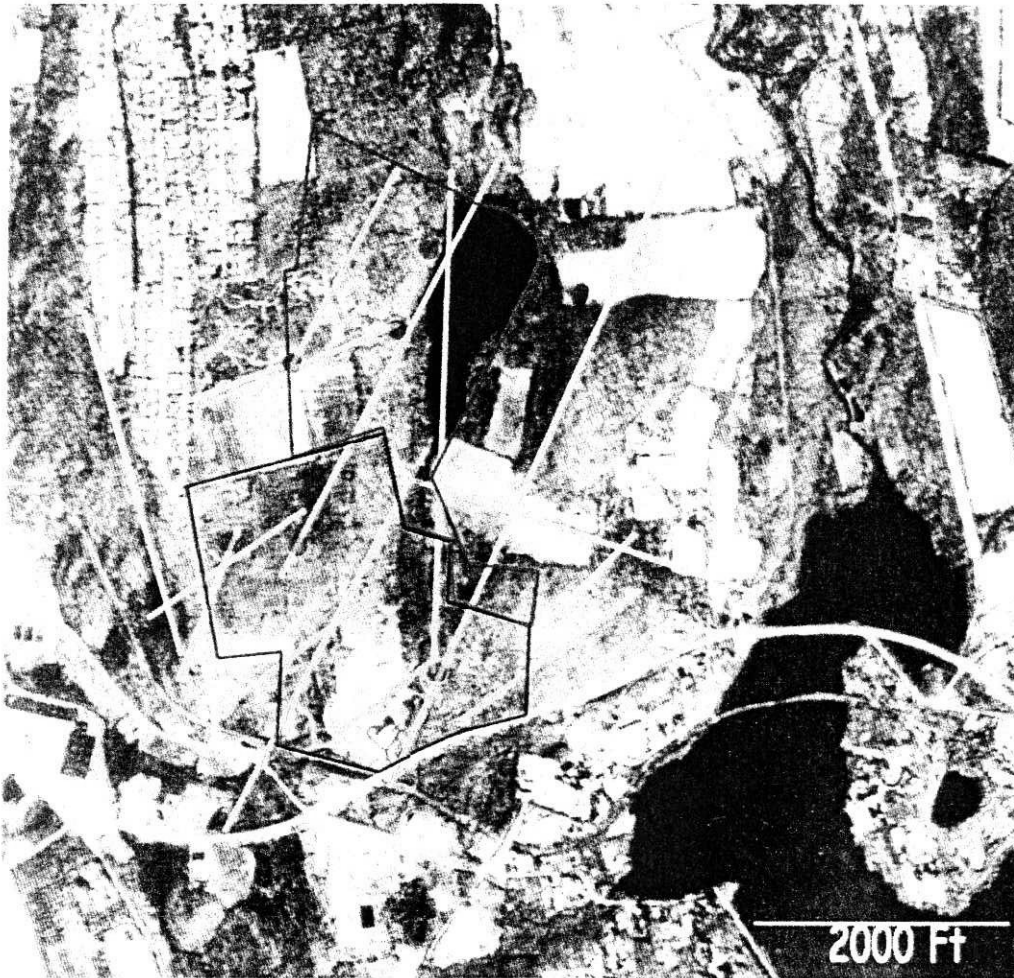
Review of the high altitude infrared photography shows that the project area has several fracture traces trending from southeast to northwest. Regionally, most bedrock fractures tend to be oriented in a northeast to southwest direction, indicating that these are secondary fractures to the main thrust fault along Tilly Foster Road. These tend to be shear fractures formed due to uneven tectonic forces from the southeast, causing the rock to break in roughly the same plane as the force being applied. The intersection of the two types of faults, visible at the southern-most portion of the Gateway property, forms an angle of about 30 degrees, which is a typical angle between fractures in this type of bedrock.

Several tertiary fractures are visible within the property. The tertiary fractures have limited extent and, consequently, limited displacement. Typically for ground water exploration from bed rock aquifers, an air percussive drilling rig is mobilized and drilling continues until a sufficient amount of water is developed. Subsequently the successfully developed wells are tested to determine long-term yield and to determine if there is potential deleterious impacts on neighboring private wells.

The dots shown on the above photo indicate suggested drilling locations based on the intersection of potentially productive bedrock fractures.

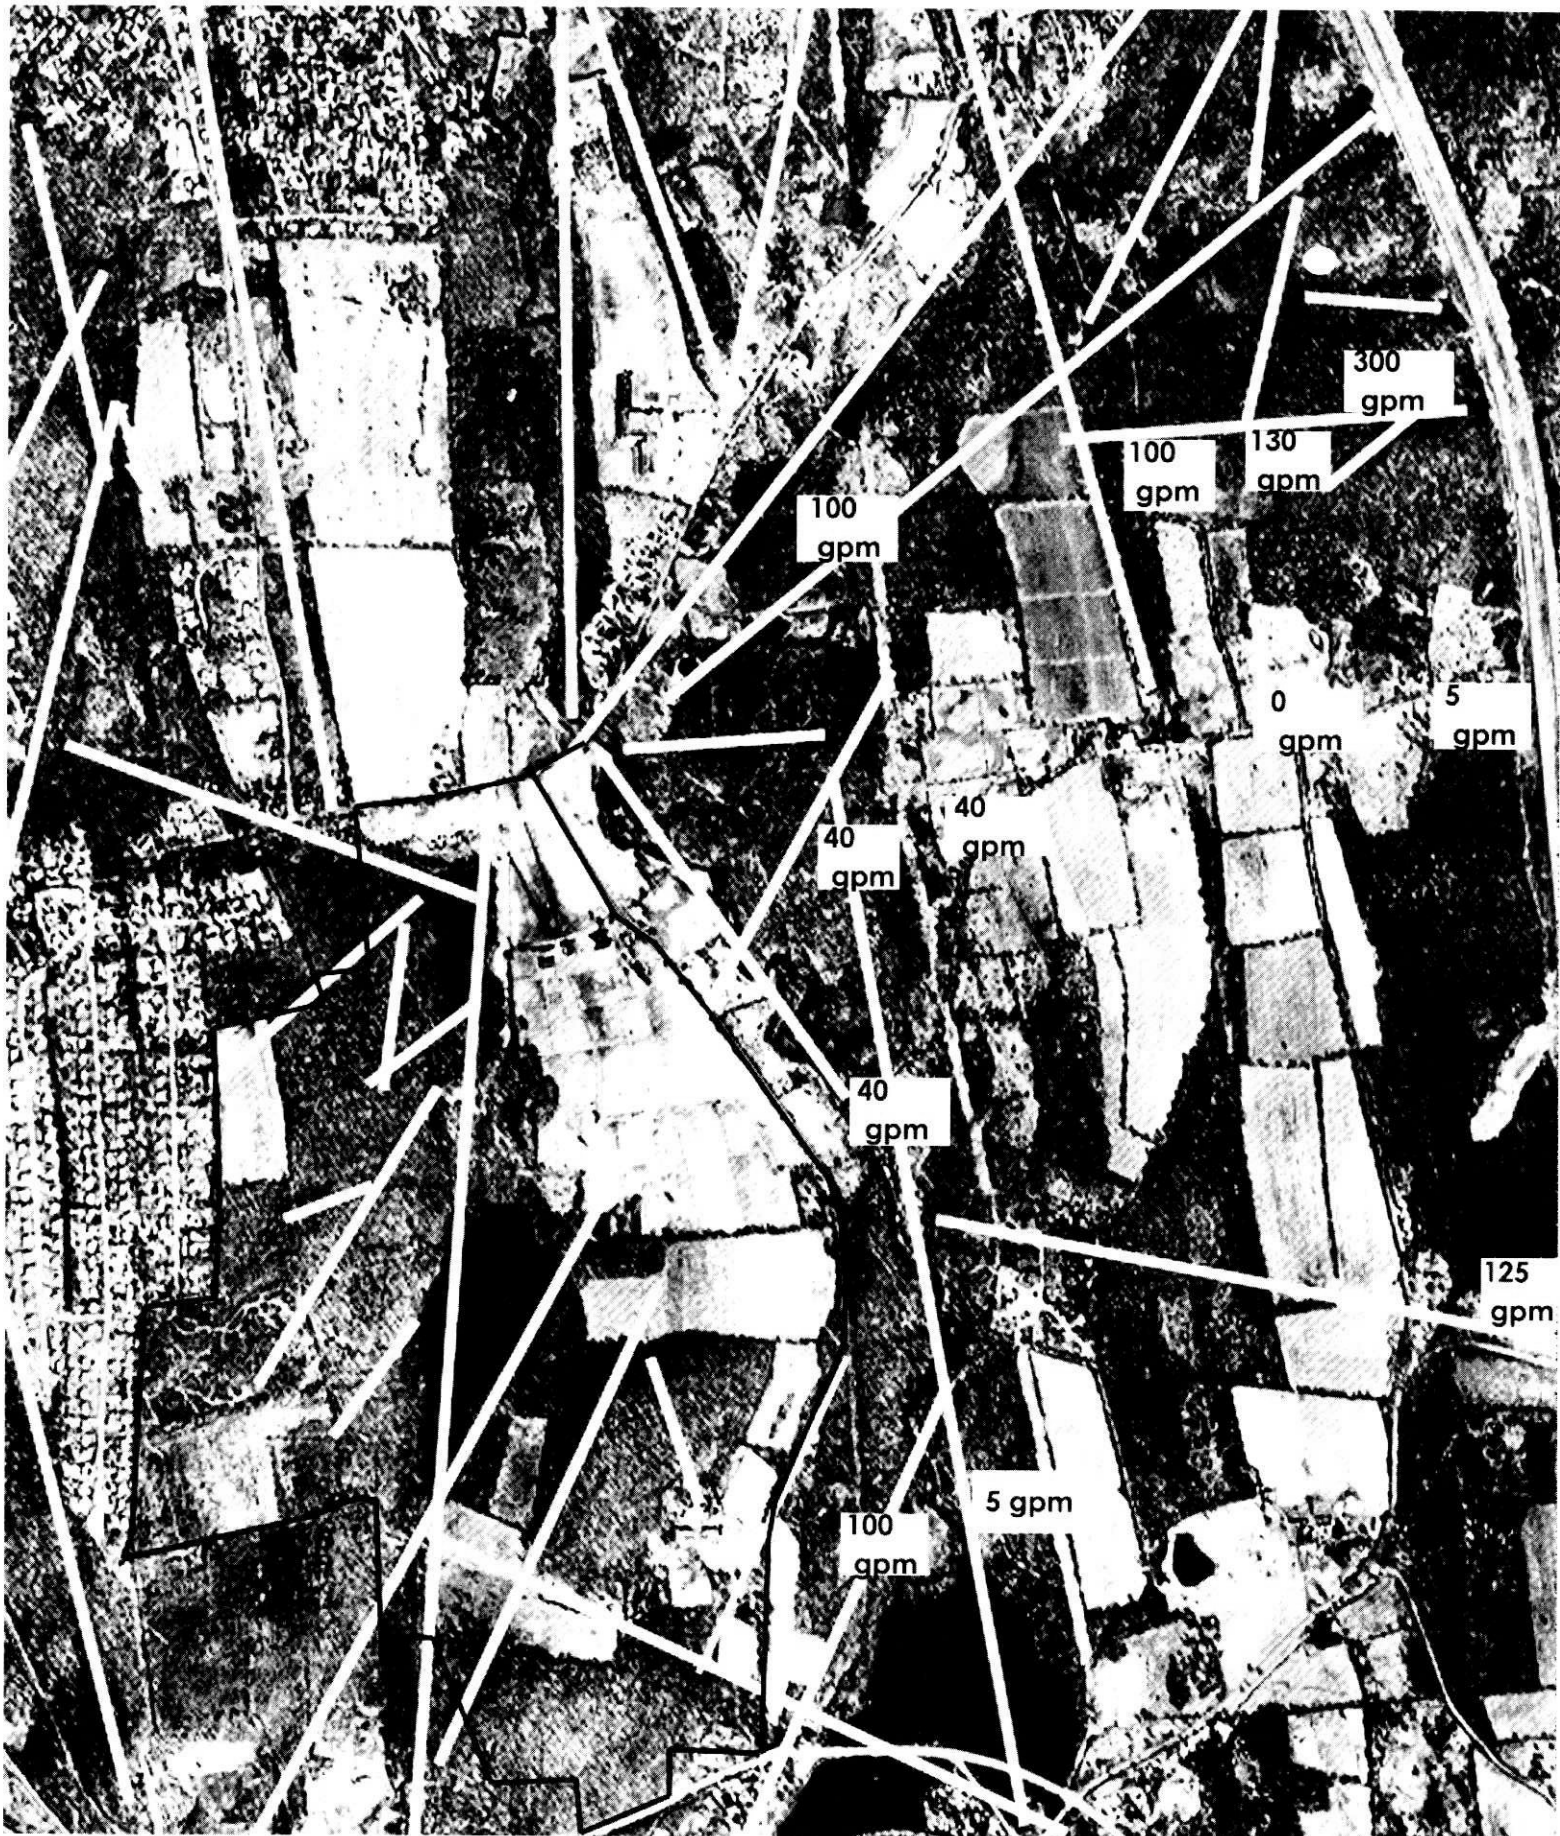
Figure Showing Existing Wells in Vicinity of Centennial Golf Club Property

Source: SSEC, Inc. (1992) for Centennial Golf Club

The following table illustrates the availability of groundwater as water supply at Centennial Golf Club demonstrated in 1992. The two accompanying figures illustrate the locations of groundwater wells in the site vicinity.

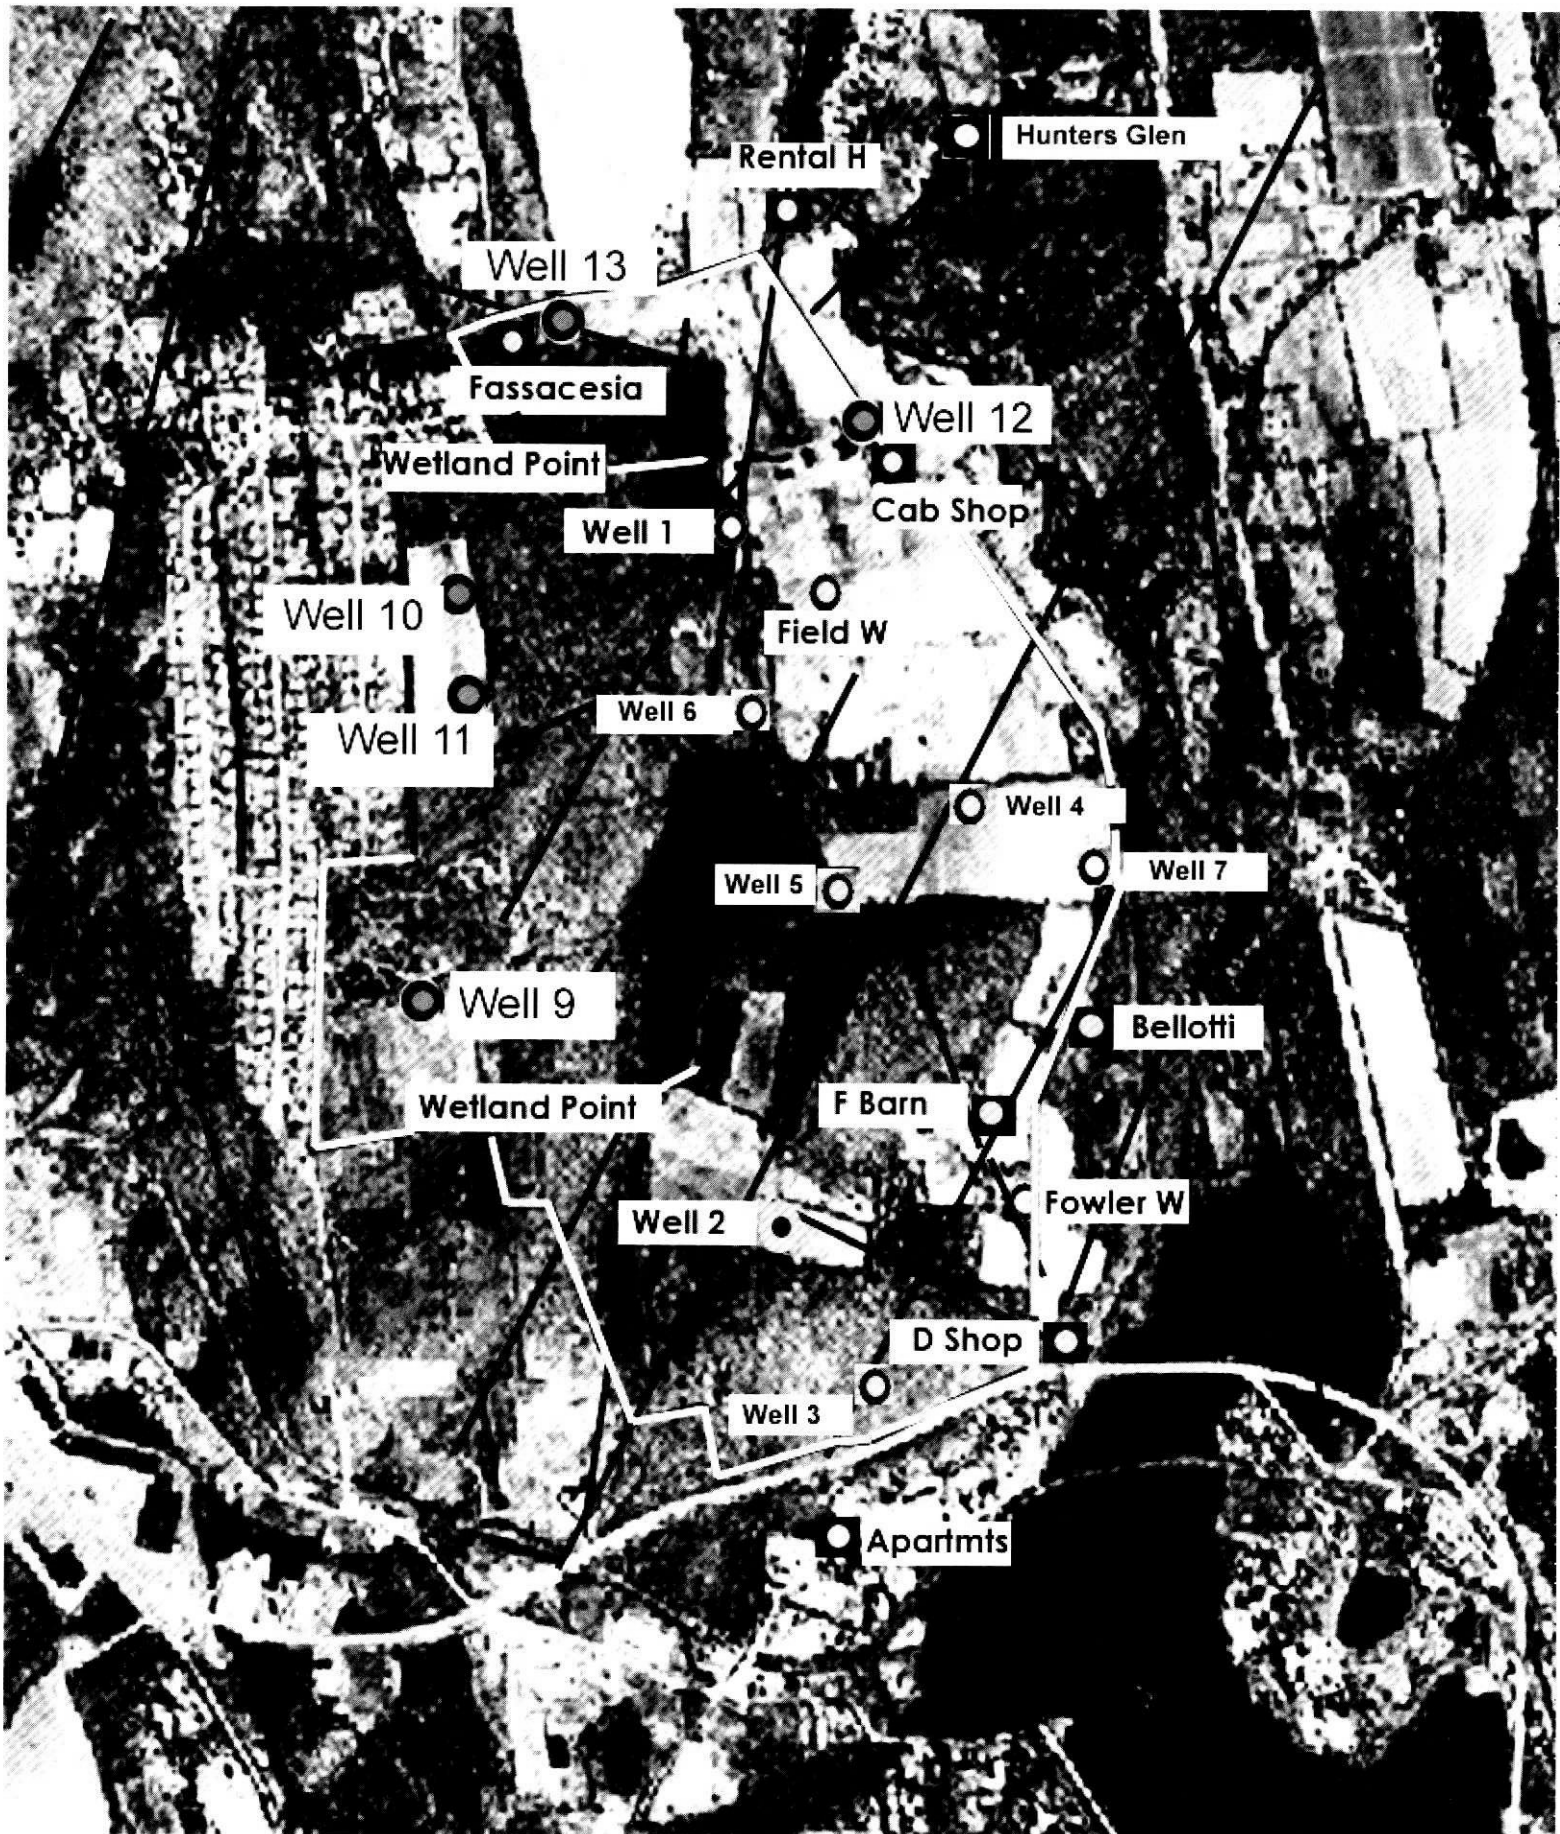
Figure Showing Existing Wells at Centennial Golf Club Property

Source: SSEC, Inc. (1992) for Centennial Golf Club
